# Evidence for the breakdown of an Angkorian hydraulic system, and its historical implications for understanding the Khmer Empire

This paper examines the construction and design of a 7-km long embankment, probably built for King Jayavarman IV between 928 and 941 CE, as part of a new capital. We calculate that the capacities of the outlets were too small, and conclude that the embankment failed, probably within a decade of construction, so that the benefits of the reservoir stored by the embankment and the access road on top of it were lessened substantially. We explain how the design was sub-optimal for construction, and that while the layout had a high aesthetic impact, the processes for ensuring structural integrity were poor. Simple and inexpensive steps to secure the weir were not undertaken. We speculate that this early failure may have contributed to the decision to return the royal court and the capital of the Khmer Empire to the Angkor region, marking a critically important juncture in regional history.

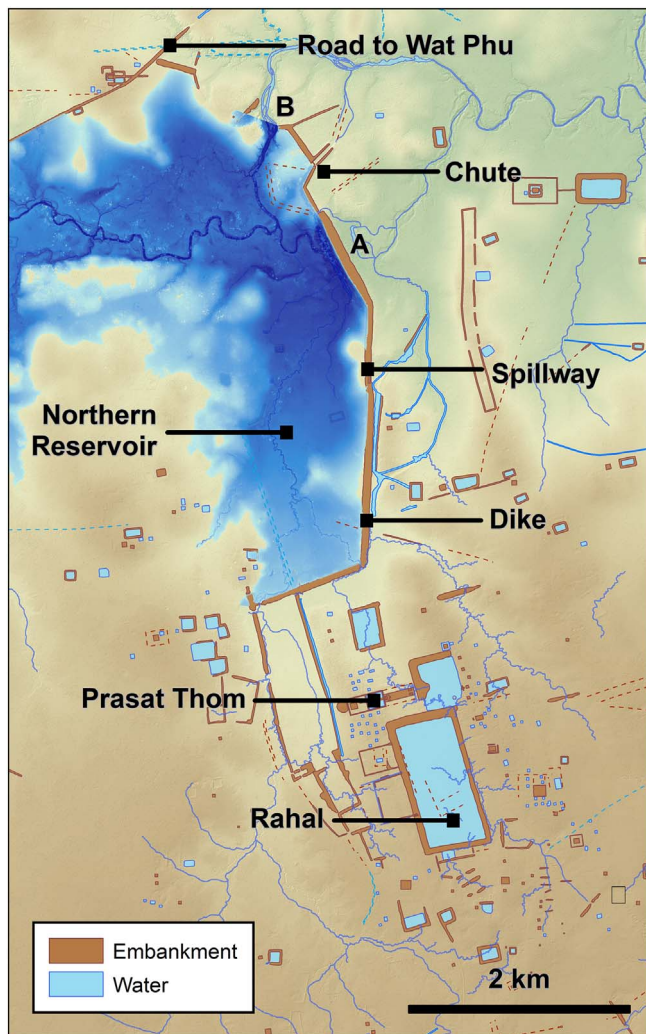
Fig. 2. Weir to north of Prasat Thom. It had two outlets, a spillway 190 m across, and a chute 230 m long with 4-m high walls 35 m apart. Note the N-S linear feature 1 km to the east of the main spillway. Imagery derived from KALC lidar data (Evans et al., 2013).

But this infrastructure was not to last. Whereas the Rongea River originally ran eastwards past Point A in Fig. 2, we see that it now runs northwards, having overtopped and broken through the embankment at Point B. Once this happened, the large lake, the unimpeded access road, and any economic benefits from the reservoir would have been lost. Did this happen before the political centre moved back to Angkor, and were the two events linked?

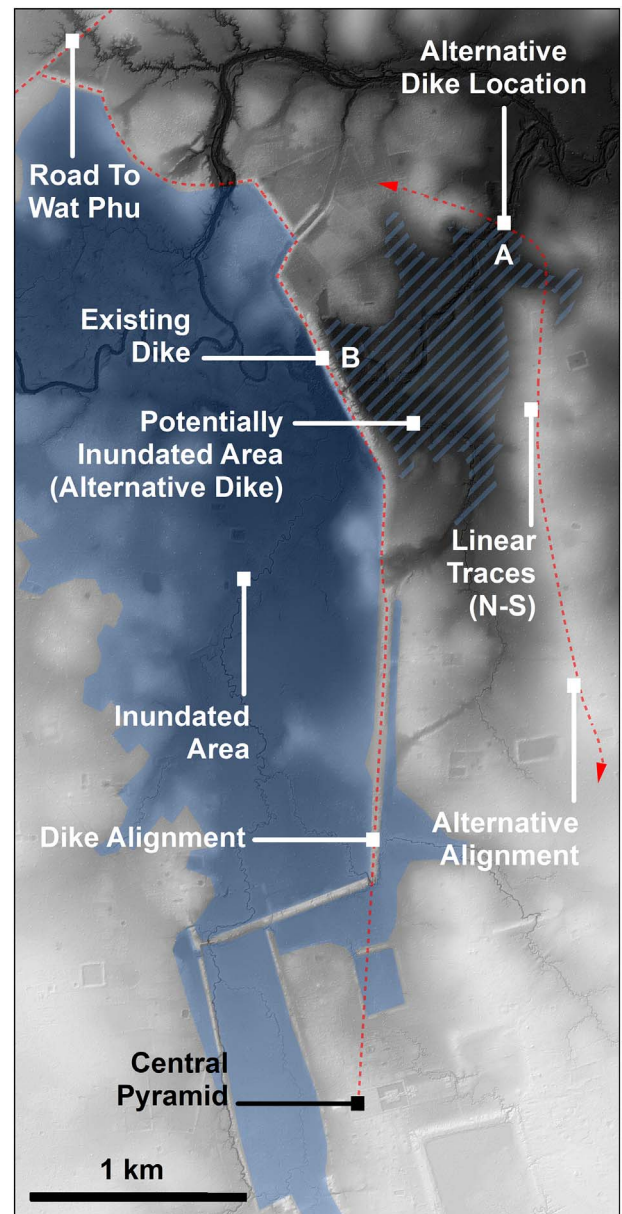
Fig. 3. Access road to Koh Ker past artificial lake formed by weir. The alternative dike location at A, to the north of the linear traces on high ground, would have been less costly to construct than the existing dike B. These linear traces indicate that an alternative access route was under active consideration. (The whiter the color, the higher the ground.)

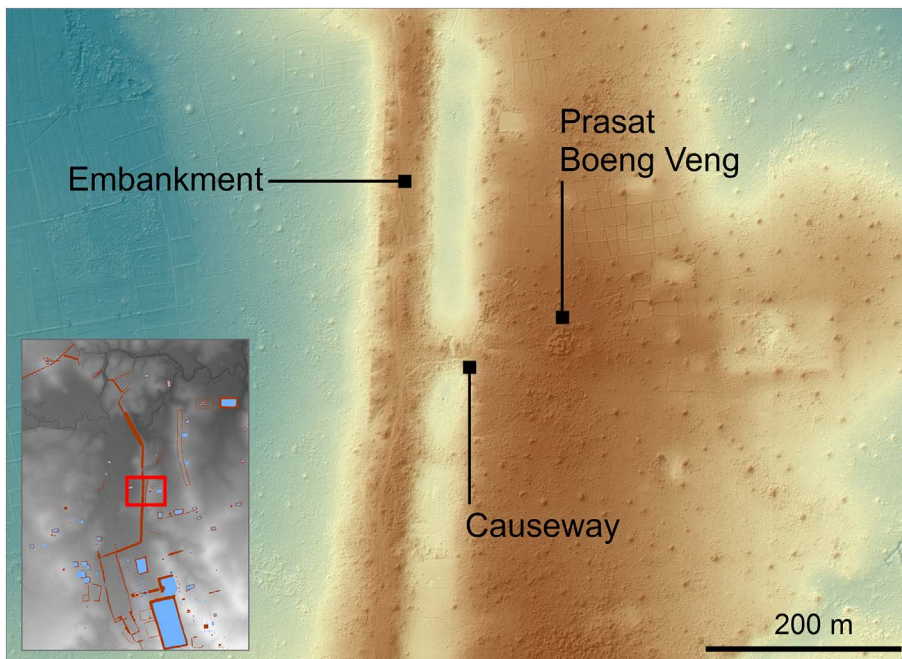
Fig. 4. Prasat Boeng Veng linked to main embankment by causeway. Water has cut a channel through the causeway, and would have flowed every rainy season. (High elevation is brown, low elevation is blue.)

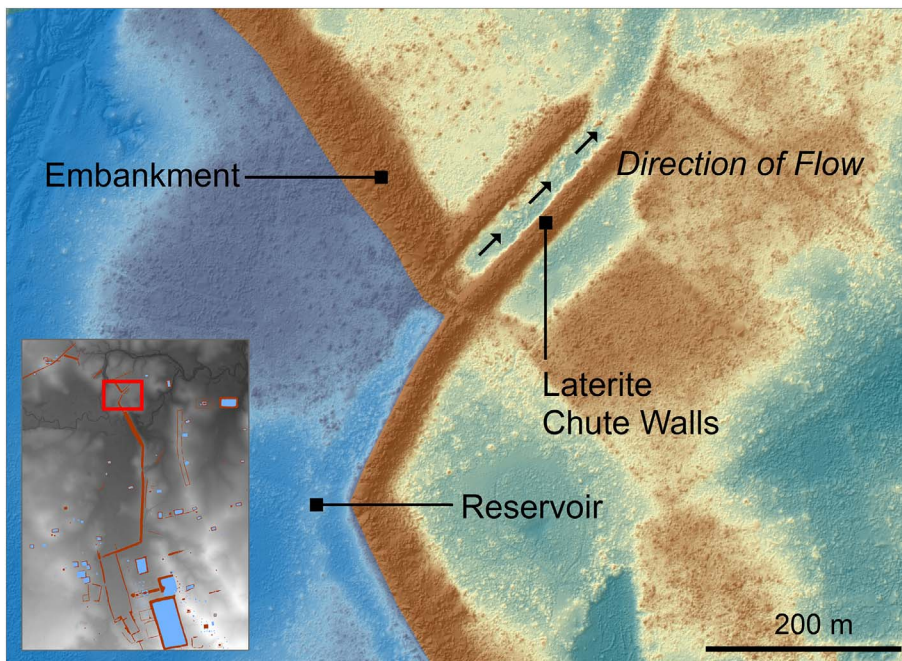
Fig. 5. Chute outlet. The laterite walls are about 4 m high at about 70.6 m ASL. See also Fig. SI 2.

This section outlines our investigation of capacities and resistance to failure of the two outlets from the reservoir, the chute (Fig. 5), and the spillway (Fig. 6). We have followed up Evans' initial investigations with field surveys from 2013 to 2016, together with excavations in 2015. Clearing of the vegetation on the spillway and at the chute showed the remains of structures with ogee-form profiles (Fig. 11), a hydraulically efficient shape in standard use for the design of many modern spillways (Chanson, 2004, 396). Bam Penh Reach north of Angkor (Lustig, 2012, 210), probably built under Yaśovarman I (889–910 CE), is the only other known example of this type of profile in the Angkorian realm (Fig. 12), although it is less well developed.

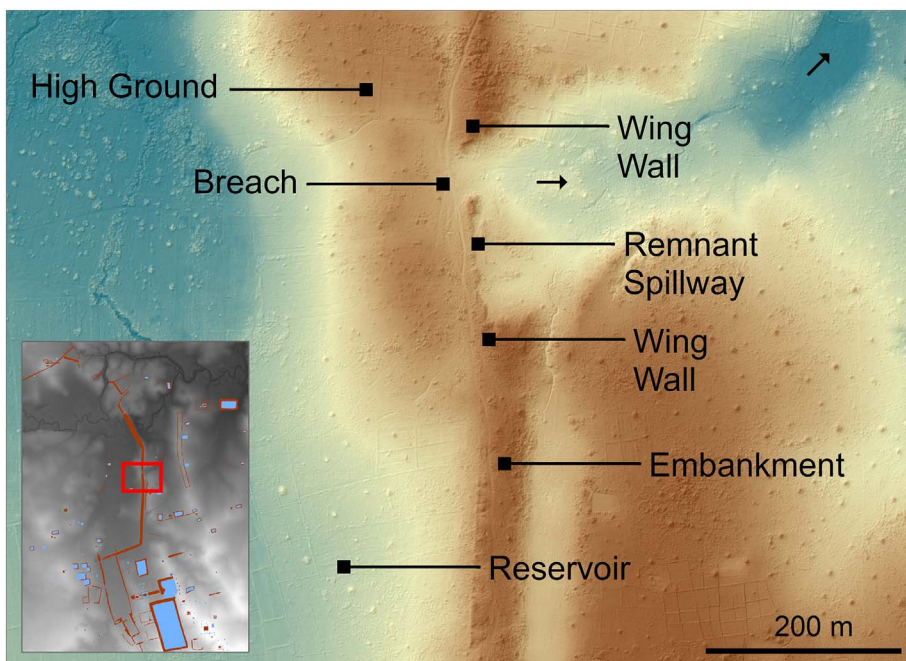
Fig. 6. Spillway with high ground upstream, and washed out at northern end. The tops of the wing walls are at about 70.6 m ASL. See also Figs. SI 3 and SI 4.

the high velocities of water flowing over the spillway. Laterite blocks have also been located as far as 500 m downstream, supporting the idea that the failure of the spillway was catastrophic. This major breach can be seen clearly (Figs. 6 and SI 3).

A deficiency in design that contributed to the failure of the embankment was that the spillway was founded on the low side of a sloping sandstone rock shelf. We judge from the lidar, together with surveys on site, that the elevation of the crest may have been originally at about 69.6 m ASL. However, there is a ridge of sandstone whose crest ranges from 68.9 m to 69.7 m ASL just upstream (to the west in Fig. 6). It is impractical to construct a spillway at a level that is at much the same level as a ridge just upstream. With the adopted layout, this high ground upstream would have impeded the flow of water from the reservoir to the spillway, so the structure's capacity for discharging excess flows was less than optimal.

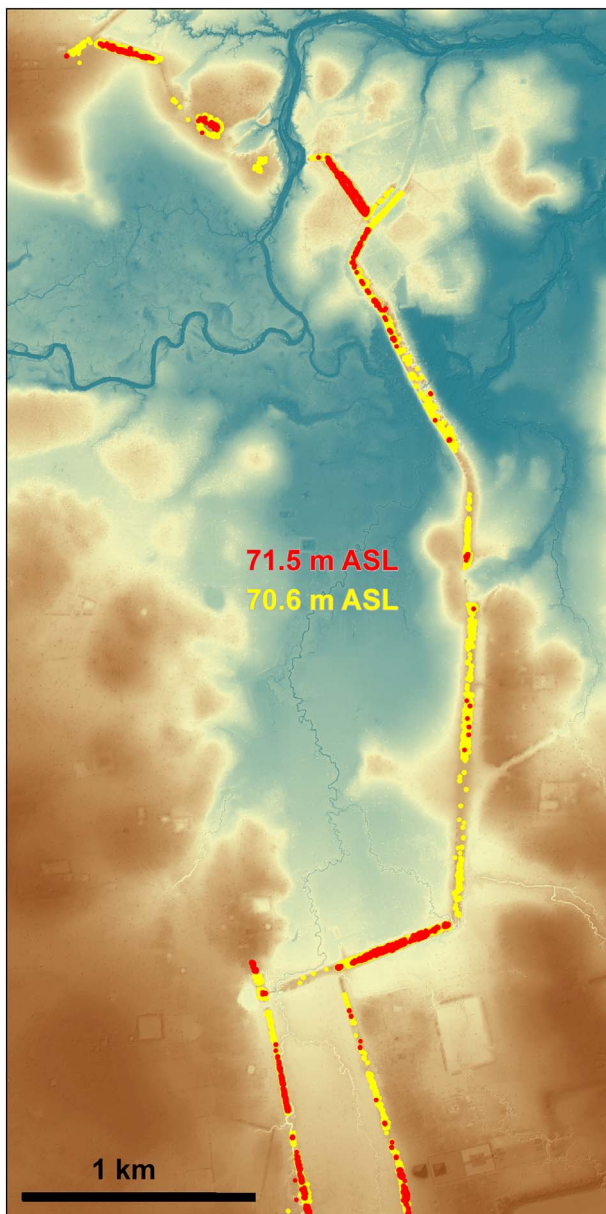
Fig. 8. Embankment showing where the crest is at or above 70.6 m ASL (yellow) and 71.5 m ASL (red), respectively.

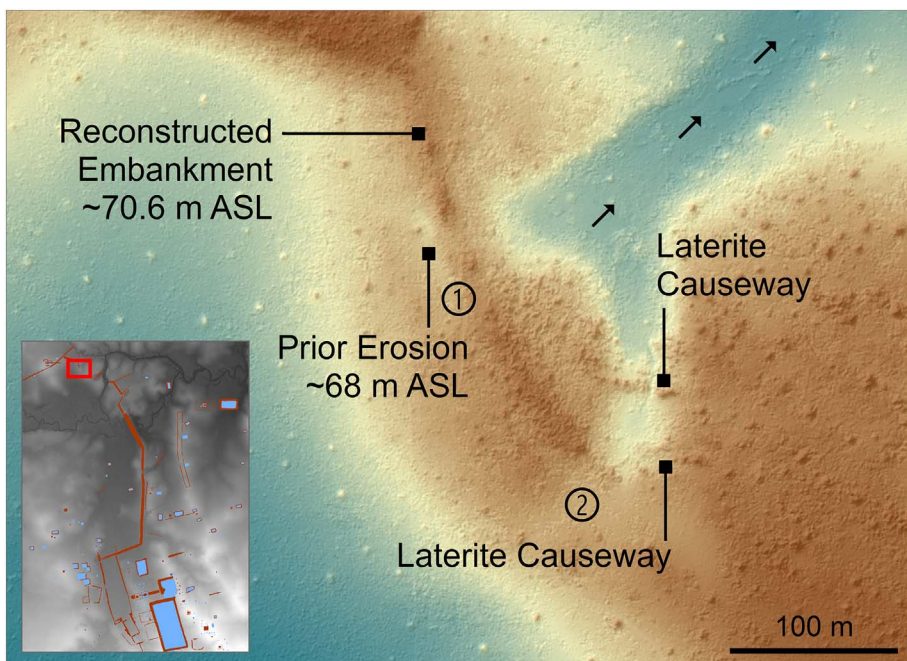
Fig. 9. Overtopping Points 1 and 2 showing indications of prior erosion having been covered over with reconstructed embankment, estimated to be at 70.6 m ASL. The lighter the colour, the higher the ground. The low ground at Point 1 at elevation ~68 m ASL appears to be the remnants of a channel created by erosion during the first overtopping, which was then filled in before being overtopped and eroded again. The laterite causeways at Point 2 would have been built after the first overtopping, which formed the channel there.

1 in Fig. 9, we see that the natural ground appears to have been eroded down to about 68 m ASL, then filled in with a 2.5 m-high embankment — if our assumption that the level of the crest was built up to around 70.6 m ASL the second time is correct.<sup>11</sup> Then this embankment was eroded again, in places, down to about 69 m ASL. At Point 2, the erosion apparently lowered the ground and formed a shallow gully on the downstream side. Two laterite pavements have been constructed across this gully, presumably after the first overtopping. These are not horizontal, suggesting that they have settled since, perhaps because their sandy-clay foundations became super-saturated and lost strength. Erosion Points 3 and 4 are shown in more detail in Fig. 10. The shape of the ground at Point 3 is consistent with the patterns created in soil when eroded by water overtopping about 200 m of a level embankment. At Point 4, the erosion was so great that a new river channel formed.

We need to offer one qualification to this assessment, however. It is sometimes difficult to distinguish between laterite blocks that have been placed on a surface as rough protection, and laterite that forms naturally below the ground and is exposed when the overlying soil erodes. We have found laterite that has formed within the main embankment, which is only about 1200 years old. However, we feel that we have differentiated between natural and placed laterite in the main correctly. In most places laterite rubble can be found on the upstream face of the embankment, but not on the downstream face as well, which we should expect if the laterite has been produced there naturally. Only at Point 1, the location that seems to have been eroded and repaired, does the exposed laterite appear to be natural (Fig. 9).

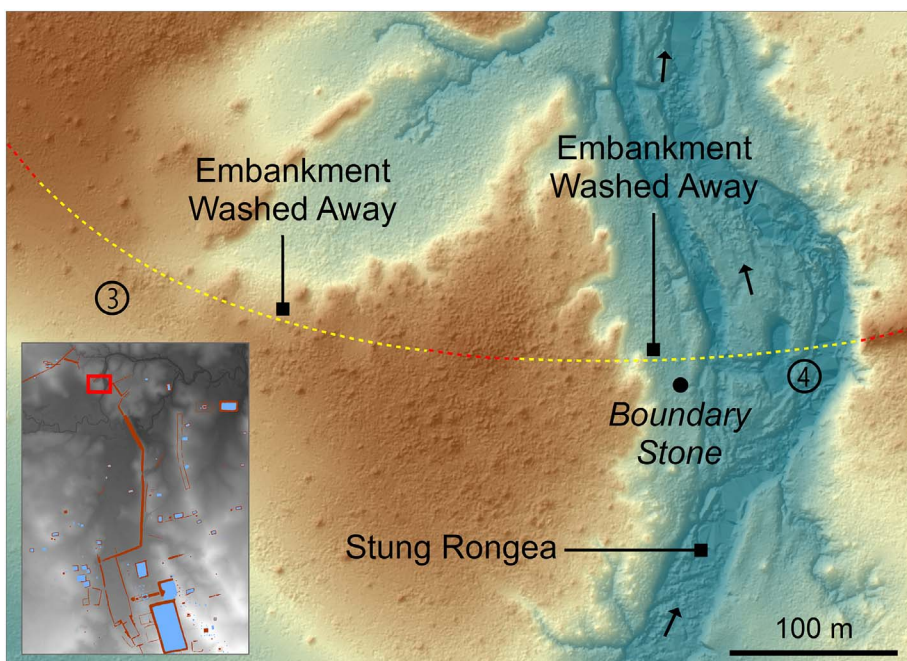
Fig. 10. Overtopping Points 3 and 4. Boundary stone in line with embankment on left bank of the Stung Rongea indicates that the embankment initially continued westwards along high ground. The yellow dotted line shows an approximate line of embankment, before being washed away.

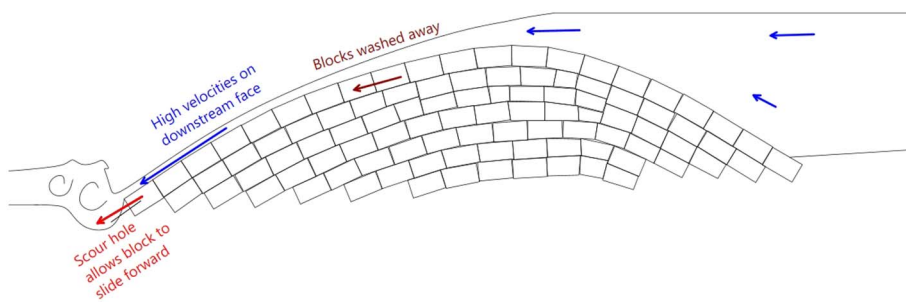
Fig. 11. Schematic diagram of laterite spillway showing zone of scour by water flowing over the ogee-form spillway.

As illustrated in Fig. 11, the water flowing over a spillway accelerates as it passes over the crest, and then accelerates further as it runs down to the toe of the embankment. Near the bottom, the water plunges into turbulent water, and could undermine the foundations supporting the toe. The flow of water over the spillway seems to have undermined the laterite blocks where they rested on clayey sand, but not so much where they had been placed on sandstone, as this part of the embankment is still largely intact. Today, one would protect the toe by installing a mechanism for dissipating the high energy to protect against erosion, but this was not done here. Where the toe was undermined, a 50-m wide section of the spillway is missing. (See also Fig.

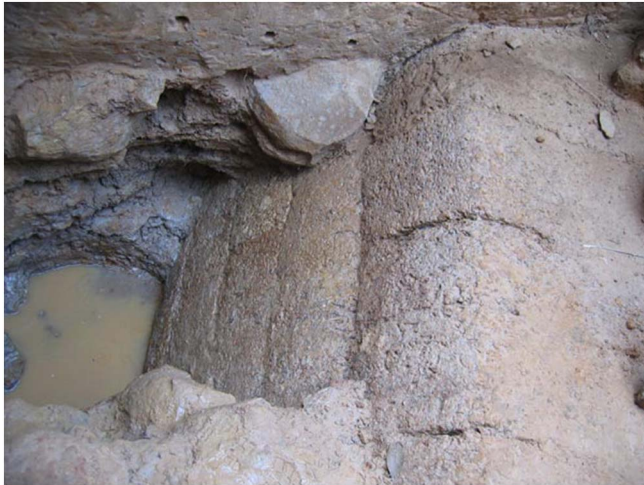
Fig. 12. Spillway at Bam Penh Reach, north of Angkor, showing ogee form at top layer of laterite. (Photo by Andrew Wilson.)

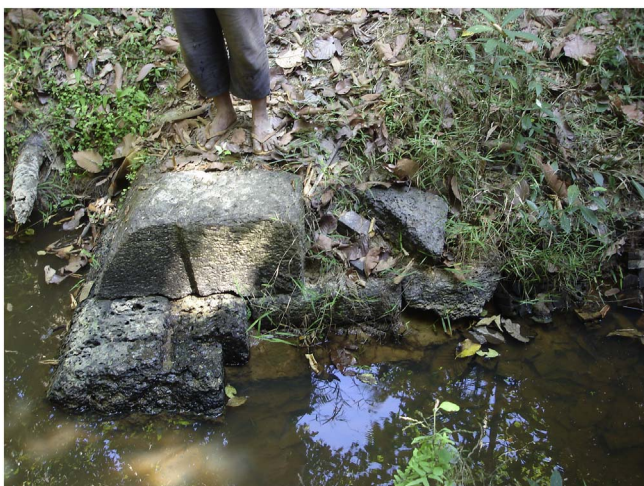
Fig. 13. Section cut through spillway at Bam Penh Reach in the 1970s, showing keying between blocks.

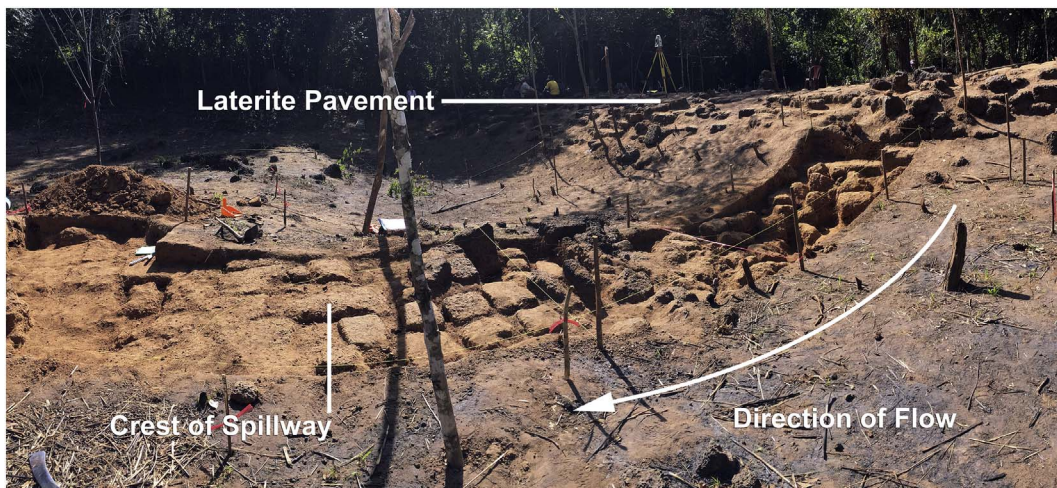
Fig. 14. Spillway in chute with crest at ~68.5 m ASL. Pavement-like structure on right with top at ~69.8 m ASL. Water would have flowed over the spillway towards the left, before the pavement was there.

The chute may have failed less dramatically than the main spillway to the south. The spillway in the chute has a much gentler slope and the blocks that eroded at the toe — again there was no energy dissipator — do not seem to have resulted in a rapid failure of the whole structure. Our probing did, however, find gaps in the subsurface laterite layer, and this was supported by the results of the ground penetrating radar (GPR) data from the chute, which showed that about a third of the spillway eroded severely, but that some of it remained largely intact. Detailed hydraulic modeling will be required to estimate the peak velocities of the water flowing over the reasonably complete portions of the spillway, but they do lend support to the idea that the water in the reservoir was not much higher than 70 m ASL when the embankment failed.

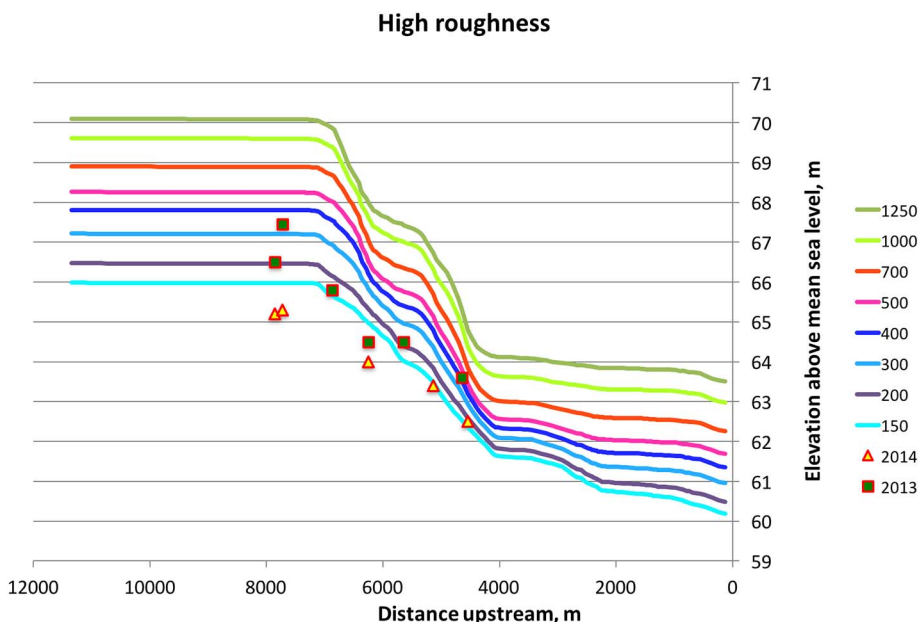
Fig. 15. HEC-RAS model results, assuming higher roughness values than normal. Points are peak water heights observed by local informants in 2013 and 2014.

against the flows derived from the HEC-RAS hydraulic model, we estimated that the flow may normally be no less than 120–300 m<sup>3</sup>/s every year, and may exceed 300–700 m<sup>3</sup>/s on average one year in ten. The lowest estimated flows are calculated on the assumption of higher than estimated values of roughness in the river and the floodplain. The highest flows are for lower than estimated values of roughness. In what follows, we assume the high-roughness flows, so that our conclusions will be conservative (Fig. 15). The results for normal values of roughness and for roughness less than normal are in Supporting Information SI 4.<sup>16</sup>

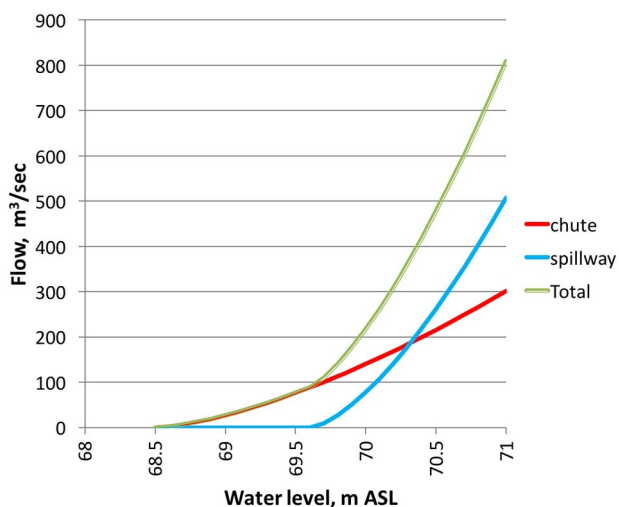
Fig. 16. Flow over both spillways increasing with water level in reservoir.

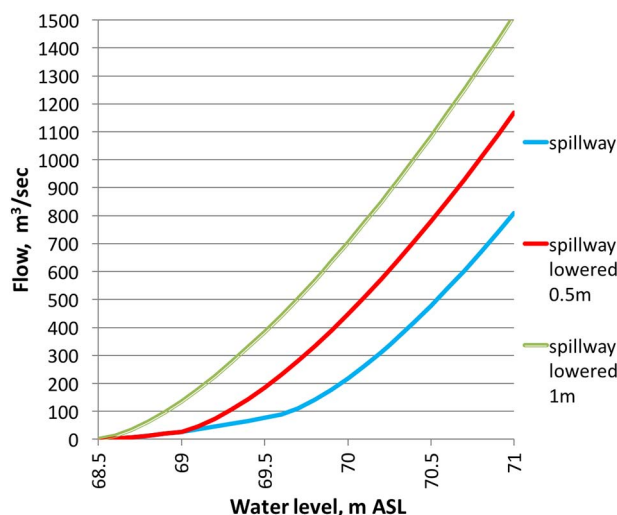
Fig. 17. Total flow over spillway and chute, and with spillway lowered.

spillway. Fig. 17 shows that the embankment could have been protected by lowering the crest of the main spillway by between half a meter and a meter. The capacity of the spillway would then have increased substantially, and the level of the reservoir during floods would have been lower as well, making the risk of overtopping negligible. Another option could have been to increase the width of the chute, thereby enlarging its capacity. It is possible that the danger of the embankment overtopping even with the crest at 70.6 m ASL may not have yet become apparent, because the combined capacity of the spillway and chute was found to be adequate for the flows that had been experienced till then.

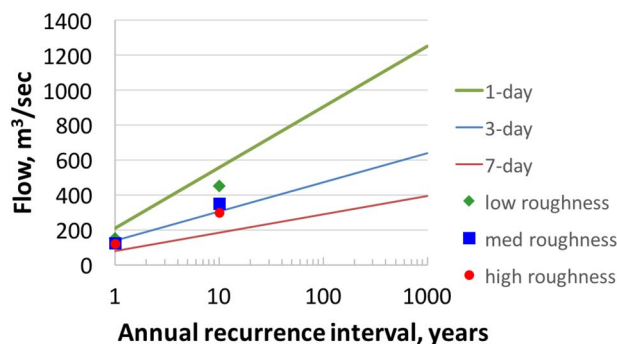
Fig. 18. Flood-frequency curve, derived from local and regional data. Markers indicate the results from the hydraulic modeling.

This scenario assumes simply that there has been a large and rare flood. The flood frequency derived by using the information from the villagers is plotted in Fig. 18 together with the results from the hydraulic modeling. The results from the hydraulic modeling were less than from the hydrological modeling for the 1-day flows, suggesting that the observed water levels may have been less than the actual peak. The maximum elevations reached in the reservoir are shown in Fig. 19 for the 3-day average modeling and Fig. 20 for the 1-day average modeling. The 3-day modeling indicated that the water level could

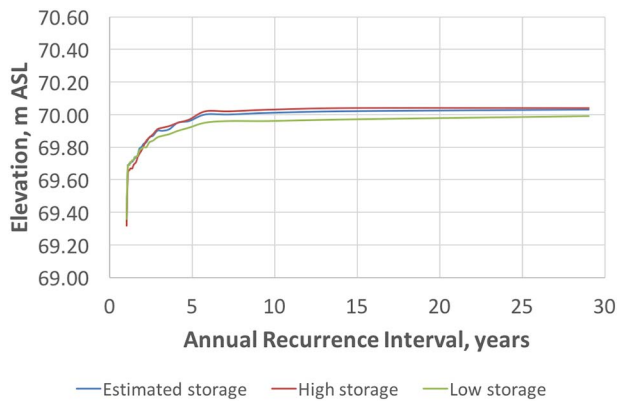
Fig. 19. Frequency of reservoir reaching different elevations, depending on estimated storage assuming a 3-day averaging of rainfall.

reach only 70 m ASL, whereas the level assumed for overtopping the embankment was 70.5 m. The 1-day model showed that the reservoir would rise to 70 m one year in three, but the 70.5 m level might be reached once in 15 years on average. However, this scenario for overtopping was judged not to be feasible, since the time taken to reach peak water level in the reservoir was anything from 3 to 60 h, and if it is agreed that the spillway and the embankment failed together, these times would be too long. This scenario, therefore, does not appear feasible.

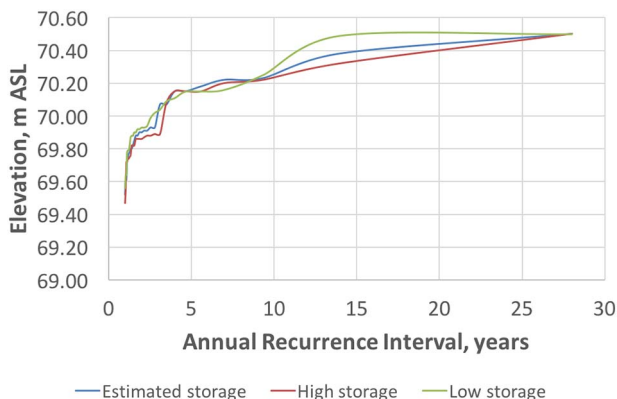
Fig. 20. Frequency of reservoir reaching different elevations, depending on estimated storage assuming a 1-day averaging of rainfall.

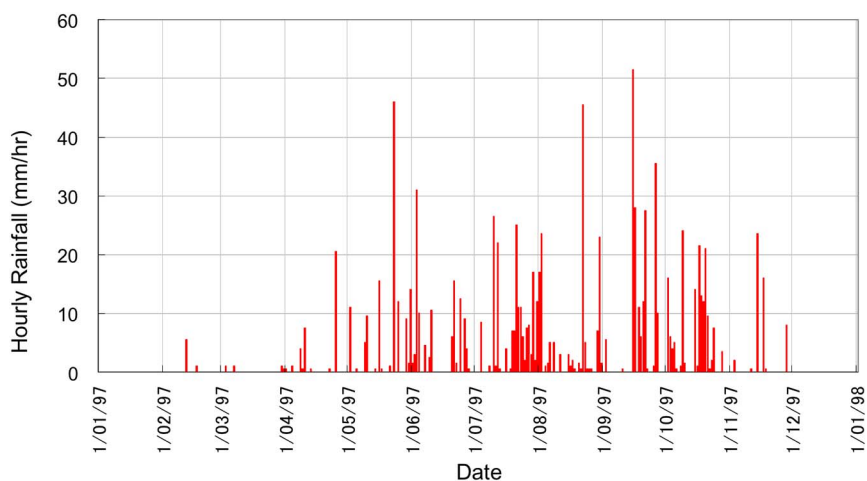
Fig. 21. Pluviometric readings at Prasat Suor Prat for 1997.

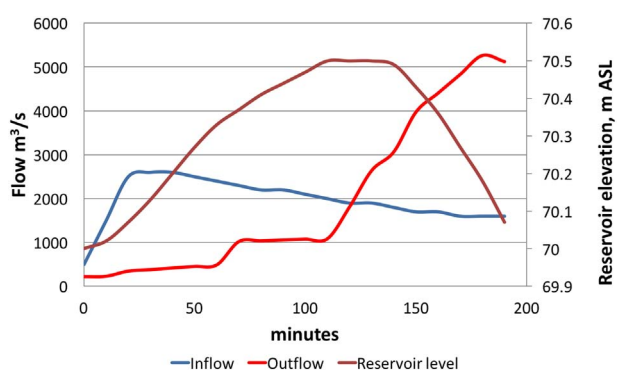
Fig. 22. Inflows, outflows and water level for overtopping by large inflows into reservoir.

We first used the model to find the inflow, which could result in the reservoir level rising from 70 m to 70.5 m ASL within 2 h.<sup>17</sup> Fig. 22 shows an inflow that simulates what is usually observed during floods, namely a rapid rise and a slow decline. We found by trial and error that the maximum flow might need to reach about 2600 m<sup>3</sup>/s for an embankment with a low point at 70.5 m ASL to overtop.<sup>18</sup>

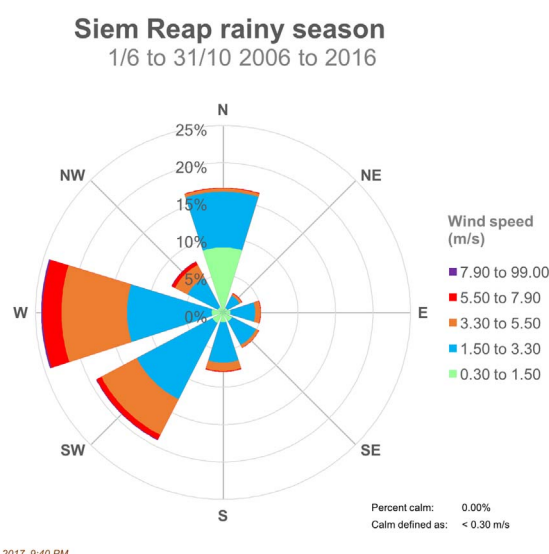
Fig. 23. Wind rose for Siem Reap Airport during the rainy season, between 1st June and 31st October. (For interpretation of the references to colour in this figure legend, the reader is referred to the web version of this article.)

up the flood as it went. We examined the wind directions for Siem Reap Airport and found that, during the rainy season (taken here as between 1st June and 31st October), the wind was coming from between the northwest and southwest (Fig. 23) for 51% of the time, over the years 2006 to 2016, the major directions of flow in the catchment.

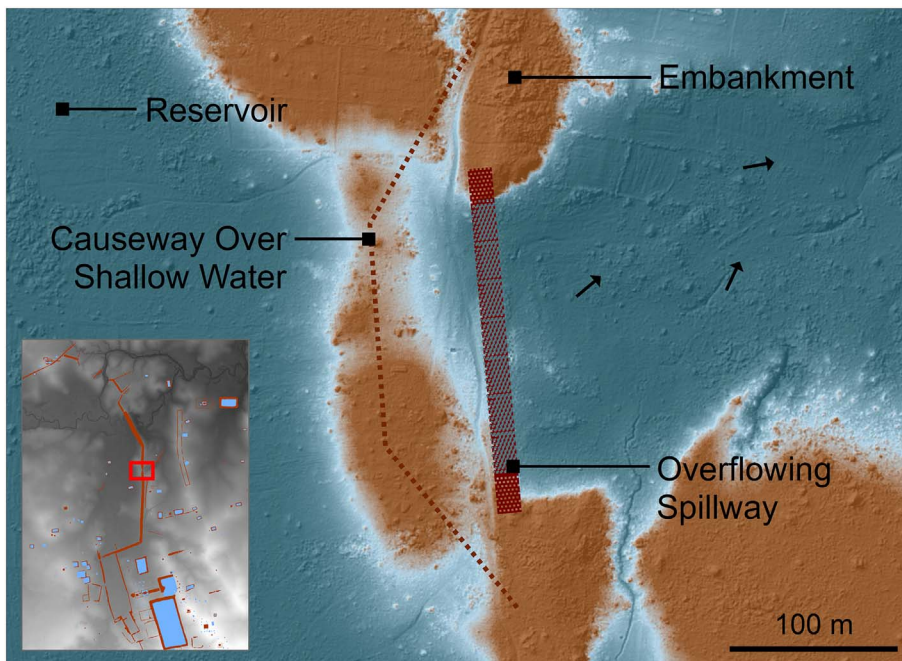
Fig. 24. Possible layout of causeway option to bypass spillway.

a causeway on piers along the high ridge upstream to bypass the spillway (Fig. 24). If so, this might help explain why the main spillway was installed downstream of high ground.
